# Explosive Decompression with Resultant Air Gas Embolism in a Fourth Generation Fighter at Ground Level

Joe X. Zhang; Jacob R. Berry; Devin P. Beckstrand

Zhang JX, Berry JR, Beckstrand DP. Explosive decompression with resultant air gas embolism in a fourth generation fighter at ground level. *Aerospace Med Hum Perform*. 2016; 87(11):963–967.

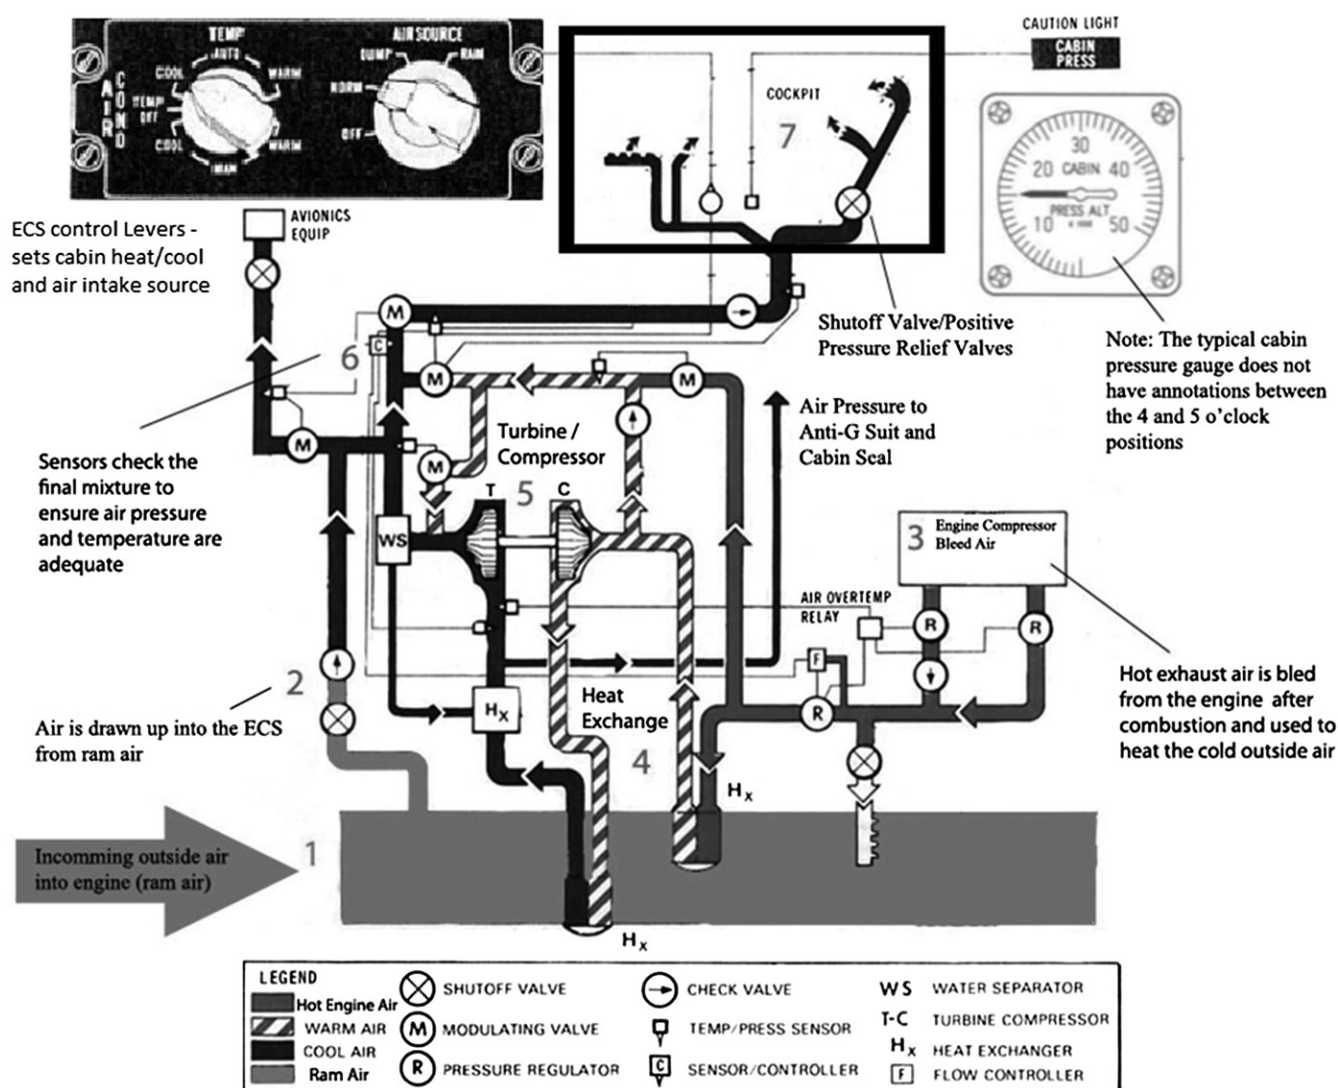
**Fig. 1.** Typical environmental control system flow diagram. 1) Air enters the aircraft through a ram air intake nozzle at the exterior of the aircraft. 2) The air flows up and continues into the cabin if it is of sufficient temperature and pressure. 3) Hot engine exhaust warms cold intake air at high altitude via heat exchange tubes at location 4. 5) Air compressors and turbines regulate the amount of airflow and pressure. 6) Sensors ensure temperature and pressure. 7) Cabin pressure is further adjusted by pressure relief valves.

To understand how an aircraft can potentially cause a DCI event, it is useful to understand how a typical ECS similar to the aircraft in this scenario provides pressurization (Fig. 1).<sup>8,9</sup> Air enters the aircraft at position 1 through a ram air intake nozzle at the exterior of the aircraft. The air flows up to position 2 and continues into the cabin if it is of sufficient temperature and pressure as measured by probes (6). Hot engine exhaust warms the cold air at high altitude (3) via heat exchange tubes at position 4. Air compressors and turbines at position 5 regulate the amount of airflow and pressure. A final check valve will ensure proper temperature and pressure before air enters the cabin (7). All of this is controlled by the onboard computer and adjusted by the cockpit controls.<sup>9</sup>

The ECS in this case clearly malfunctioned. For the event to occur, the positive pressure relief valves at position 7 likely failed. In addition, either the computerized control sensors at position 6 must have also failed to detect the increased pressures and continued to operate the compressor pump at position 5 or the compressor may have failed to respond to a shutoff signal. This event would require at least two or more redundant safety systems to fail simultaneously, which accounts for its rarity. While the ECS was turned off earlier, the pilot kept the engine on, which could also further complicate the situation as a lot of the air pressure comes directly from the engine intakes. A complete teardown and inspection of the ECS system on this aircraft, unfortunately, identified no failed components. After reassembly and inspection, this aircraft returned to service and reported no further ECS malfunctions to date.

On review of this case, we realized a lack of understanding of this type of event from aircrew and emergency responders. Should future pilots find themselves in an overpressurized cockpit on the ground, we recommend they immediately shut down the ECS along with the aircraft engine, and wait inside a closed cabin until cockpit pressurization normalizes to ground level. This will allow the canopy seal air leak to slowly equilibrate to outside pressures and reduce the risk of rapid decompression. Breathing supplemental 100% oxygen would add an additional protective factor. If potential for rapid or explosive decompression is unavoidable, the pilot should avoid breath holding during canopy or hatch opening. Most, if not all aircraft, have a manual exhaust valve that maintenance personnel can access or a pilot operated dump valve on the ECS controls. Crews must take care when using these options to reduce excess cockpit pressure at a controlled rate over several minutes to reduce risk of rapid decompression. This information should be useful for development of future emergency response checklists.
