# Instrument Failure, Stress, and Spatial Disorientation Leading to a Fatal Crash With a Large Aircraft

Arne Tribukait; Ola Eiken

Tribukait A, Eiken O. Instrument failure, stress, and spatial disorientation leading to a fatal crash with a large aircraft. *Aerosp Med Hum Perform*. 2017;88(11):1043–1048.

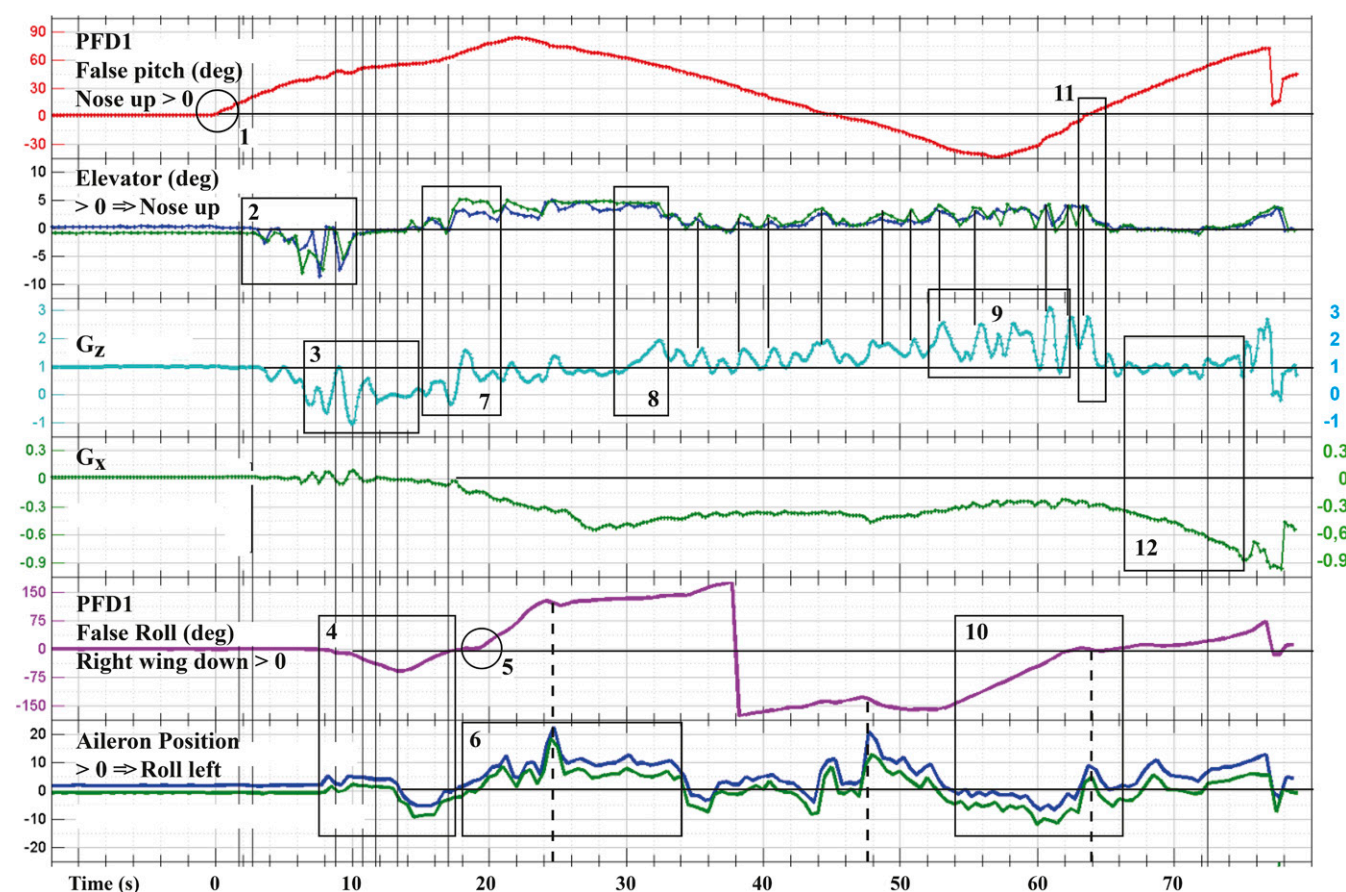
Notably, recorded roll and pitch attitude (**Fig. 1**), obtained from the DFDR, represent the malfunctioning inertial reference unit 1; they were presented on the primary flight display 1 (PFD1) in front of the pilot in command, who was pilot flying. For inertial reference unit 2, which most likely was functioning adequately, there are no corresponding recordings. Based on other flight data, estimates of the real attitude, as presented on PFD2 (in front of the first officer, who was monitoring), have

**Fig. 1.** Selection of DFDR variables (adapted from Appendix 1, Ref. 8). Critical events, phenomena, and relationships are highlighted by circles, squares and lines. Pitch and roll represent the malfunctioning PFD1 (there are no recordings from PFD2, which most likely was functioning correctly). 1) Sudden pitch-up indication. 2) The response of pilot flying with the control column. 3) Reduced/negative  $G_z$ . 4) Aileron deflection causing temporary left-roll. 5) Erroneous roll-right indication. 6) Pilot flying tries to correct for indicated roll. 7) Due to nose-down trim pilot flying must pull the control column in order to achieve  $G_z = 1$ . 8) At  $t_{30-33}$  nose-down trim is reduced, making it possible to maintain 1  $G_z$  with elevators in neutral position. 9) Pronounced increase in  $G_z$  as the aircraft enters a right-turn; fluctuations might interfere with reading functioning instruments. 10) PFD1 indicates that the aircraft is approaching level flight from an extreme left-bank; aileron deflections suggest that pilot flying tries to facilitate this roll movement and to stop it at 0°. 11) When indicated pitch is 0° elevators return to neutral position and  $G_z$  to 1.0. 12) The situation at  $t_{63}$  has similarities with that at  $t_0$ , but now pilot flying does not respond to the indicated pitch up; while  $G_z$  is constant, there is an increasing negative value of  $G_x$ , possibly inducing a sensation of forward tilting from upright position. Continuous vertical lines show how peaks in  $G_z$  are preceded by peaks in elevator position. Dashed vertical lines highlight the association between extreme aileron deflections and marked reductions in indicated roll-right rotation.

Pilot flying (PF) had commenced approach briefing and pilot monitoring (PM) was confirming when, shortly after midnight, DFDR recorded a sudden increase in the aircraft's pitch attitude (Fig. 1;1). This erroneous information was presented on PFD1 (in front of PF) but not on PFD2. The discrepancy between the PFDs automatically disengaged the autopilot, generating acoustic warning signals (Fig. 2). After 2 s (at  $t_2$ ) the pitch-up, indicated by PFD1, was 15°, but altitude and speed remained unchanged. PF

uttered an exclamation of astonishment and reacted instantaneously by pushing the control column; at  $t_3$ , the elevators were deflected in the nose-down direction and the stabilizer was trimmed nose-down (Fig. 1;2). Notwithstanding, the indicated pitch-up increased, exceeding 30° at  $t_5$ . In addition, red arrows, calling for a nose-down input, appeared on PFD1 (probably also on PFD2, but pointing oppositely). A high rate of descent followed.  $G_z$  (the component of the gravito-inertial force vector acting in the head-to-seat direction) declined; during approximately 10 s it was  $\leq 0$ , with a minimum of -1.0 (Fig. 1;3). In conjunction with transitions between positive and negative  $G_z$ , irregular sounds from loose objects in the cockpit were recorded by the cockpit voice recorder. Registered roll displayed a left-banking with a maximum of 50° (Fig. 1;4); acoustic bank-angle warnings sounded and PM said "Turn right." At  $t_{17}$ , maximum operating speed (315 kn) was exceeded, activating the overspeed warning. At  $t_{18}$ , the aircraft's roll position was again 0°. So far, PFD1 was correctly indicating the roll attitude.

At  $t_{20}$  PFD1 began to display, erroneously, a rapid right-wing-down roll rotation (Fig. 1;5); exceeding  $110^\circ$  at  $t_{24}$ . This indicated roll motion continued, with irregularities, during the remaining course of events (exceeding  $400^\circ$ ). At  $t_{20-23}$ , bank-angle warnings sounded and PM said “Turn left.” During  $t_{20-34}$ , DFDR recorded aileron deflections of great magnitude, as for rolling left (Fig. 1;6). The effect was, according to calculations,<sup>8</sup> that the aircraft, whose roll position at  $t_{20}$  was close to zero, at  $t_{24}$  was tilted left-wing down  $140^\circ$ . At this moment the aircraft was, according to calculations, pitched nose-down by almost  $40^\circ$ , but PFD1 indicated a pitch-up of  $80^\circ$ .

The aircraft's subsequent movements cannot be established with certainty. The interval  $t_{24-50}$  is characterized by increasing speed, aileron deflections as for performing left-wing down roll maneuvers, bank-angle warnings, increasing  $G_z$  (with pronounced fluctuations) and height loss. The 3-D graph of the flight path does not reveal any deviations from a straight course. At  $t_{30}$ , indicated airspeed exceeded the aircraft's maximum design speed (400 kn); the altitude was then 24,000 ft. During  $t_{30-33}$  the nose-down trim of the stabilizer was reduced (Fig. 1;8), at  $t_{44}$  engine thrust was reduced to idle.

After  $t_{50}$  there was, according to the 3-D graph, a right-turn with decreasing radius. During  $t_{52-64}$ ,  $G_z$  was approximately 2, with vigorous fluctuations and peaks of 3 G (Fig. 1;9). The graphs representing the malfunctioning attitude indicator of PFD1, elevators, ailerons and  $G_z$  display certain noticeable relationships. PFD1 indicated that the aircraft at  $t_{54}$  had a very large left-bank, but that there was a rightward roll rotation. Aileron deflections are compatible with an intention of PF to perform such a movement, with a brief counter-action when indicated roll was  $0^\circ$  (Fig. 1;10). The indicated roll rotation was, in fact, stopped at that very moment. For a short while ( $t_{63-64}$ ) also indicated pitch was  $0^\circ$ , and PF saw on his attitude indicator that the aircraft was horizontal in pitch and roll. Concomitantly, the elevators returned to the position of straight-ahead level flight and  $G_z$  abruptly decreased to 1.0 (Fig. 1;11), remaining nearly constant until the aircraft hit the ground, at  $t_{77}$ .

As to the maneuverability of the aircraft at high speeds (for which aerodynamic knowledge is limited), two observations suggest that the aircraft was, in fact, maneuverable until the end. Firstly, peaks in  $G_z$  were preceded (with a fraction of a second) by peaks in elevator position (Fig. 1). Thus, variations in  $G_z$  were due to activities of the pilots and the elevators were functioning adequately. When the nose-down trim of the stabilizer was reduced at  $t_{30-33}$ ,  $G_z$  increased (Fig. 1;8). The increasing trend of  $G_z$  and the fact that  $G_z$  was +1 during the last inverted phase implies that the wings gave their usual lift. Secondly, at moments when the ailerons displayed particularly large left-wing-down deflections, there were notable reductions in the roll-right rotation indicated by PFD1 (Fig. 1). Thus, even if inertial reference unit 1 did not provide correct information on the aircraft's attitude it was not insensitive to roll movements, and the aileron deflections had an effect in the direction desired by PF.
