# Canadian Ultralight Accidents in Water (1990 to 2020)

Conor MacDonald; Christopher Brooks; Ross McGowan; Ari Rosberg

MacDonald C, Brooks C, McGowan R, Rosberg A. *Canadian ultralight accidents in water (1990 to 2020)*. *Aerosp Med Hum Perform*. 2023; 94(6):437–443.

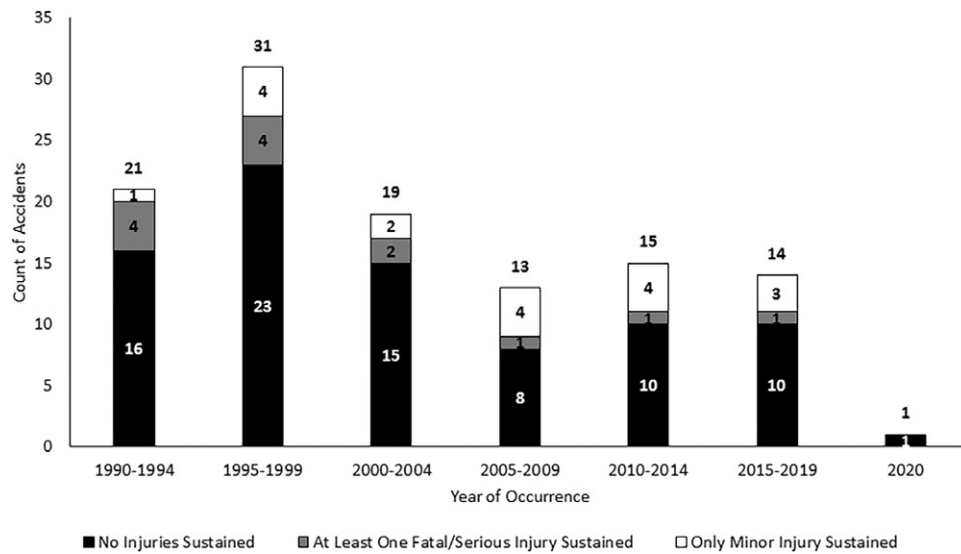
The number of accidents per year ranged from 0 (2011) to 13 (1997), with a median of 3 and an interquartile range of 3. **Fig. 1** shows the count of accidents per 5-yr span during this

**Fig. 1.** Count of ultralight accidents terminating in water annually.

time, stratified by the number of accidents in which at least one fatal/serious injury or only minor injury had occurred.
